INTRODUCTION

The Project consists of a conditions assessment of an existing two story structure. The original building located at 85 Main Street in South Hadley was a single story structure built circa 1926. A second story was later added in 1941. The attached single story garage was added in 1968. The present day structure has an approximate footprint of 17,440 square feet.

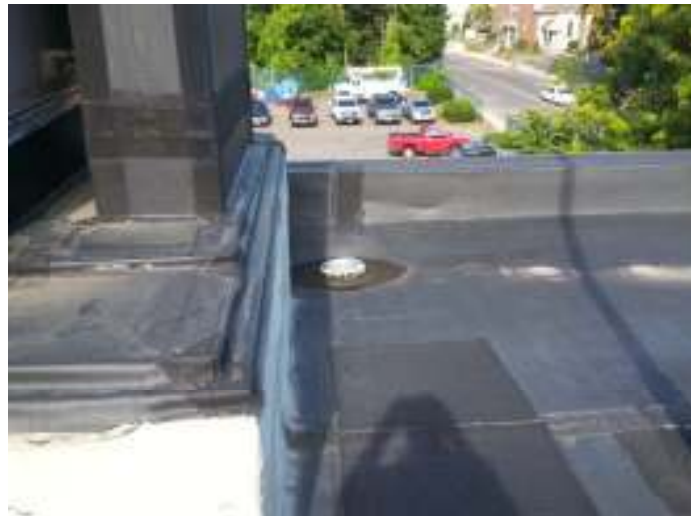
The two story office building has membrane roof with brick parapets around the four sides. The roof has two roof drains and there is evidence that at some point in time there has been an issue with ponding. The drain on the west side must have been clogged or was not functioning properly. Each drain should be cleaned and inspected to avoid the additional loading from ponding.

Photo 1 - Roof Parapet and Drain

Prior to the beginning of the 2014-2015 snow season, the two roof drains on the roof of the two story office building should be cleaned and inspected. Maintenance of this type will prevent ponding and the addition load it would impose upon the existing roof structure.

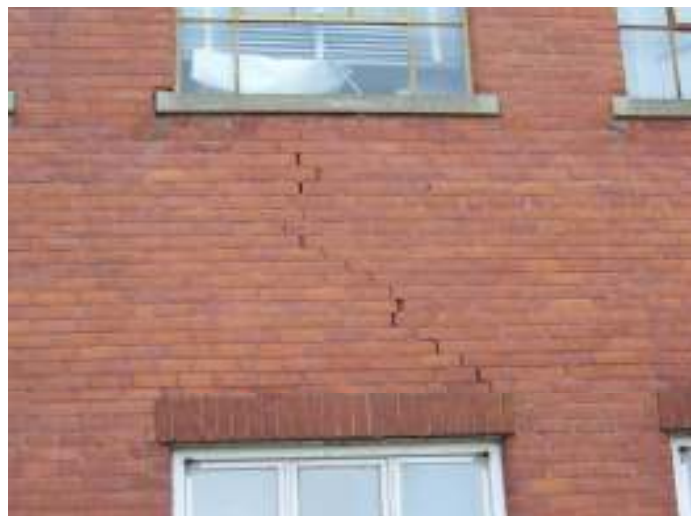
The exterior wall assembly of the office building is a multi wythe brick masonry. The walls are load-bearing and therefore transfer the roof and floor loads to the foundation. On both the east and west walls there are a series of vertical cracks and sections need repair and re-pointing. The steel lintels above the windows appear to be in generally fair condition.

Photo 2 – Stepped Cracks in Brick (West Elevation)

The cracks in the exterior wall assembly on the west side of the office building should be repaired and the deteriorated joints should be re-pointed. On east wall the series of vertical cracks should be repaired as should the crack in the foundation wall. The joints in the brick should be inspected and re-pointed as required. All of the steel lintels above the windows should be cleaned and inspected. If deemed acceptable, the lintels should then be painted. Any deteriorated lintels should be repaired and/or replaced.

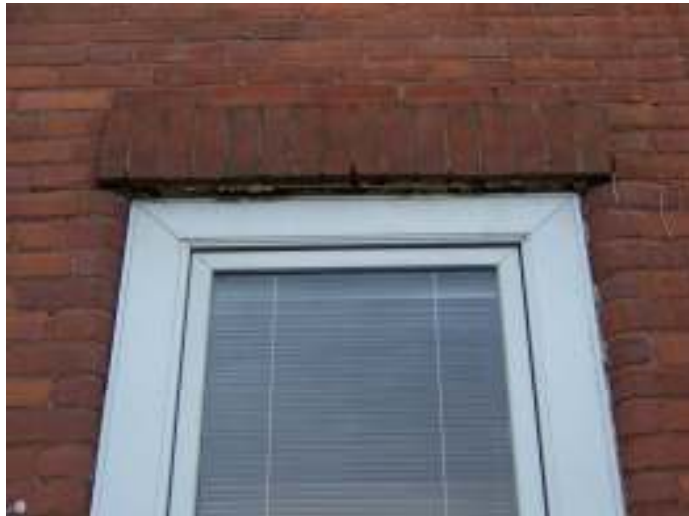
Photo 3 – Deteriorating Steel Lintels (West Elevation)

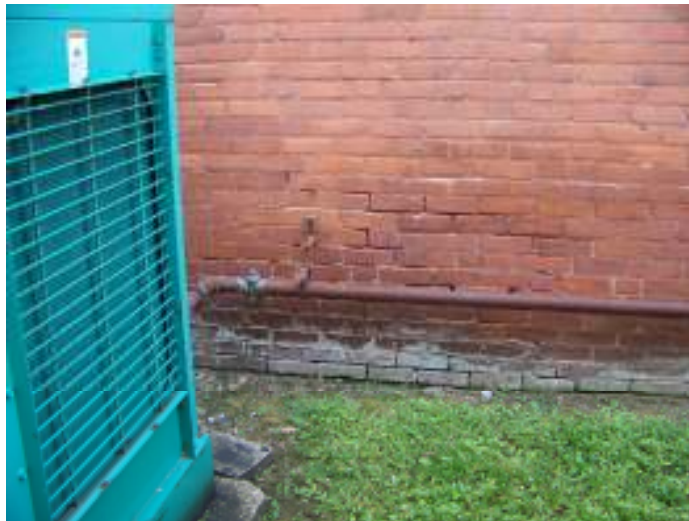
Photo 4 – Brickwork Requiring Repointing (West Elevation)

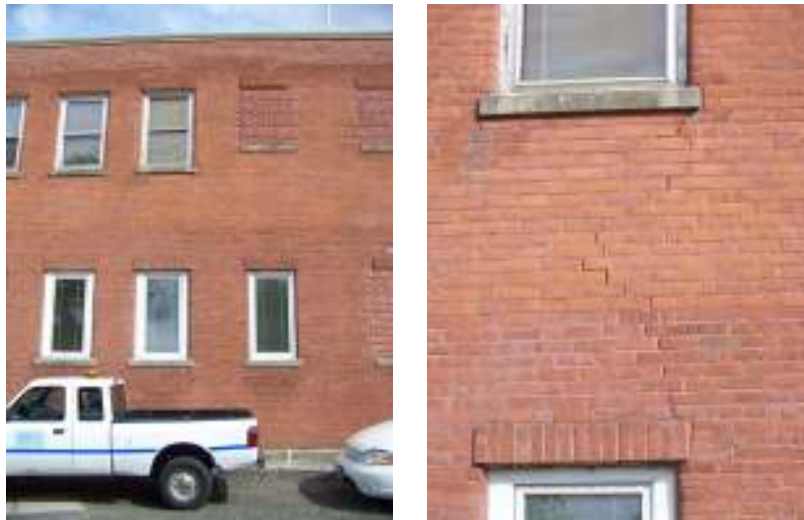
Photos 5 & 6 - Stepped Cracks in Brick (East Elevation)

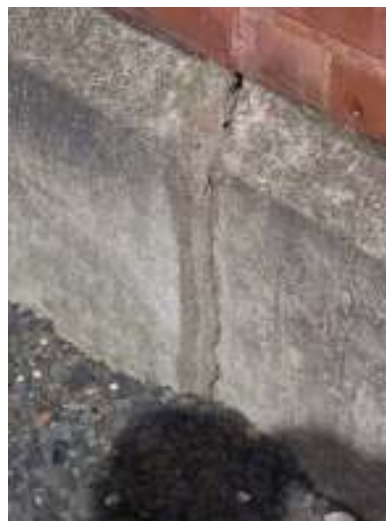
Photo 7 – Foundation Crack (East Elevation)

To prevent water infiltration into the basement, the few cracks that occur in the masonry block foundation wall should be repaired with an appropriate cementitious or epoxy material. .

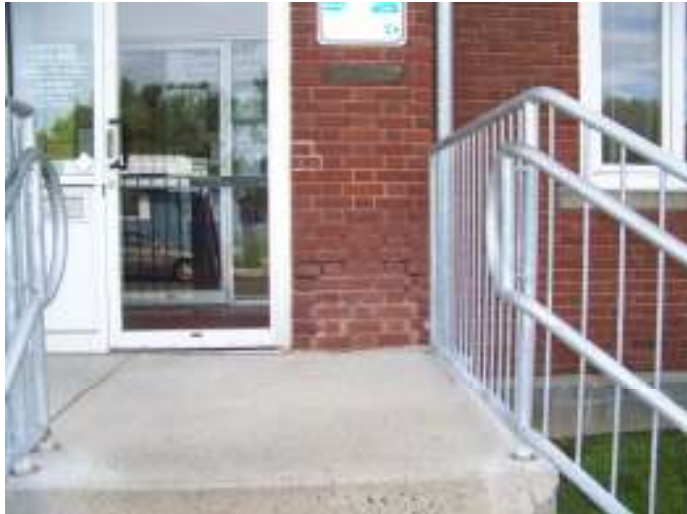
Photo 8 - Brickwork Requiring Repointing/Repair (South Elevation)

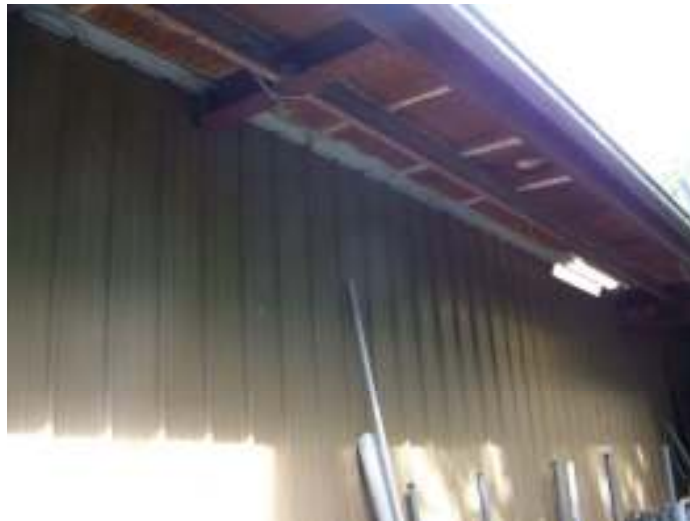
Photo 9 – Exposed Framing at PEMB Eave (North Elevation)

On the north side of the garage, the exposed framing at the eave/ soffit should be cleaned, inspected, repaired as required, and painted. The soffit should also be protected from the elements (Refer to the Architectural section).

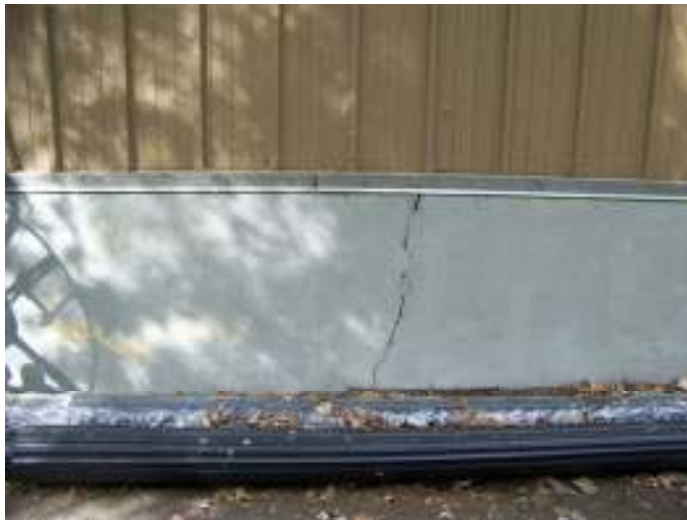
Photo 10 – Crack in Foundation Wall (North Elevation)

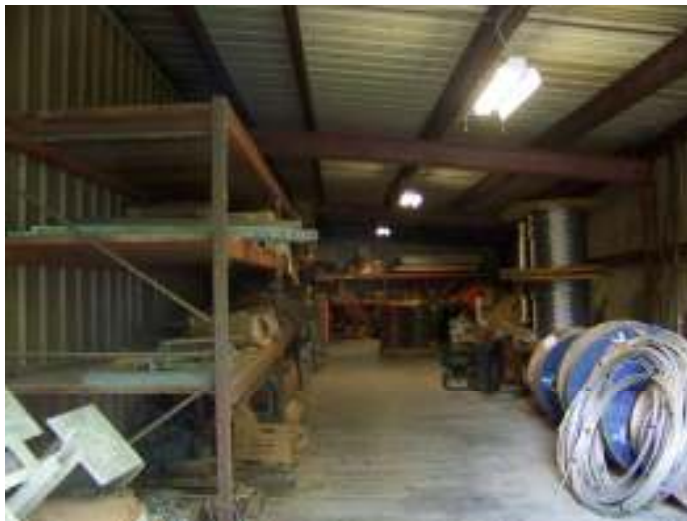
Photo 11 – PEMB Lean To at Storage Area (North Side)

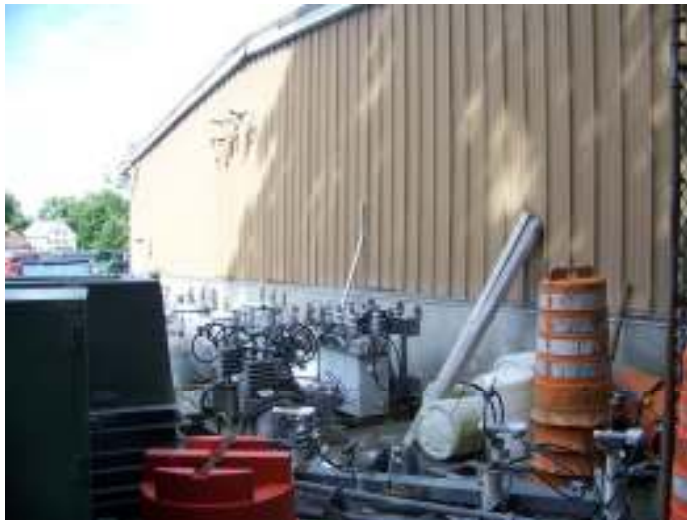
Photo 12 – Gable End Wall of Garage (East Elevation)

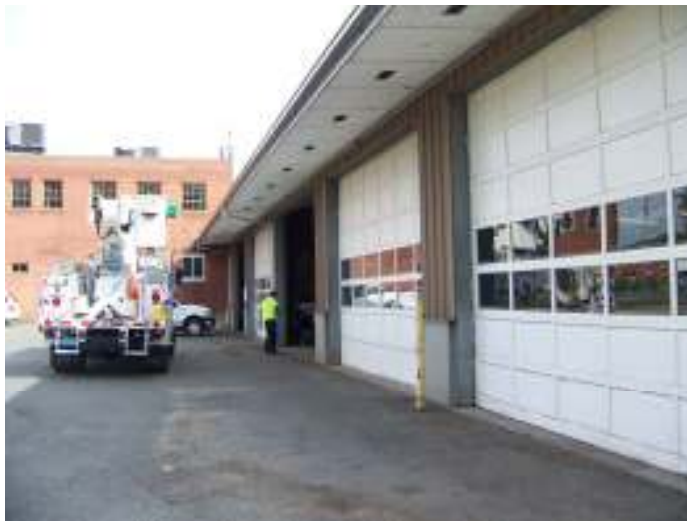
Photo 13 – Overhead Doors at Main Garage (South Elevation)

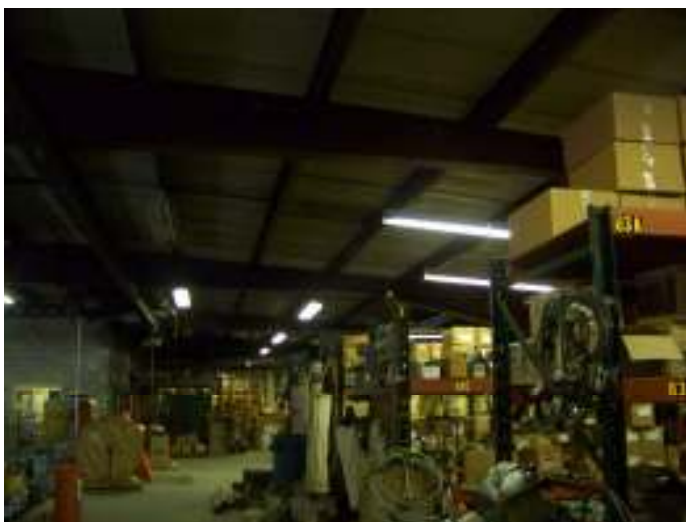
Photo 14 – Tapered PEMB Frames at Elevated Dock (Main Garage)

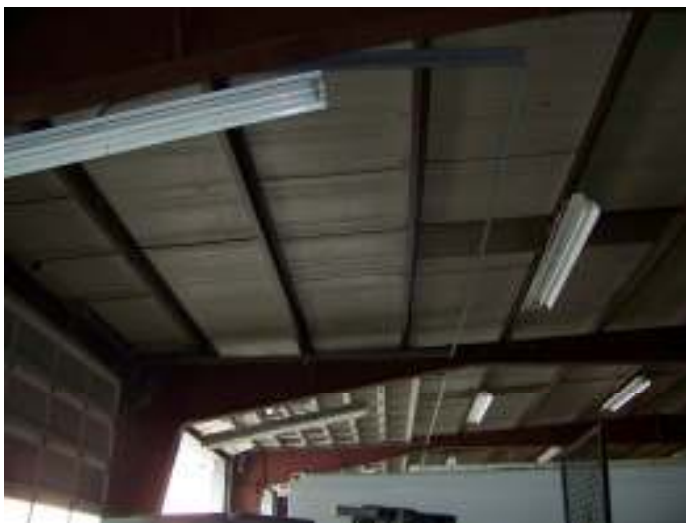
Photo 15 – Tapered PEMB Frames and Purlins (Main Garage)

The only **Mission Critical** concern that has to be address is with the purlins framing the main garage roof. Since it is a low sloped pre-engineered metal building that is more apt to hold snow and ice, the condition of these purlins should be further investigated before snowfall this year. It is not an exact science as to when the purlins will rotate enough to render them incapable to carry the imposed roof loads. One possible remedy that would stabilize and prevent further rotation of the purlins, involves the installation of solid blocking between the purlins. There are other options, including additional rod bracing, diagonal bracing, and the installation of supplemental purlins. Further analysis would be required to determine the most efficient and economical approach.

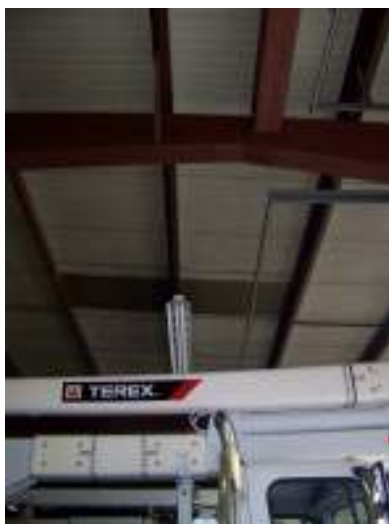
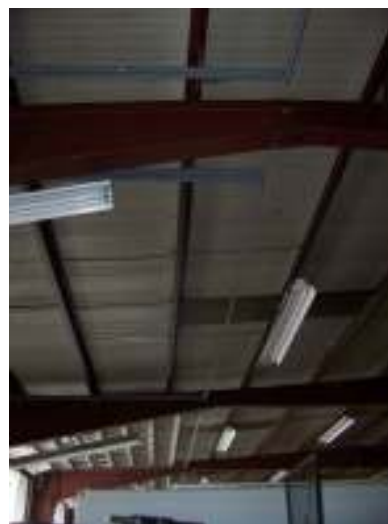
Photos 16 & 17 – Close Ups of Tapered PEMB Frames and Purlins (Main Garage)

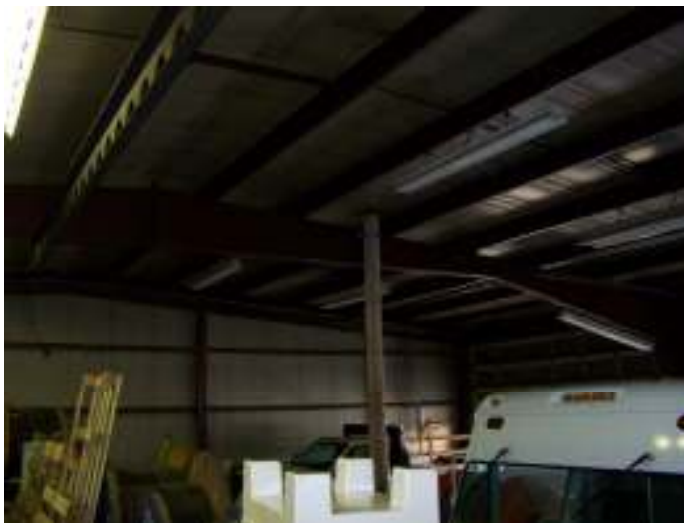
Photo 18 – Close Ups of Tapered PEMB Frames and Purlins (Main Garage)
